Origin of Beach Waste at Barry Buddon in Angus

Beach Waste at Barry Buddon, Angus

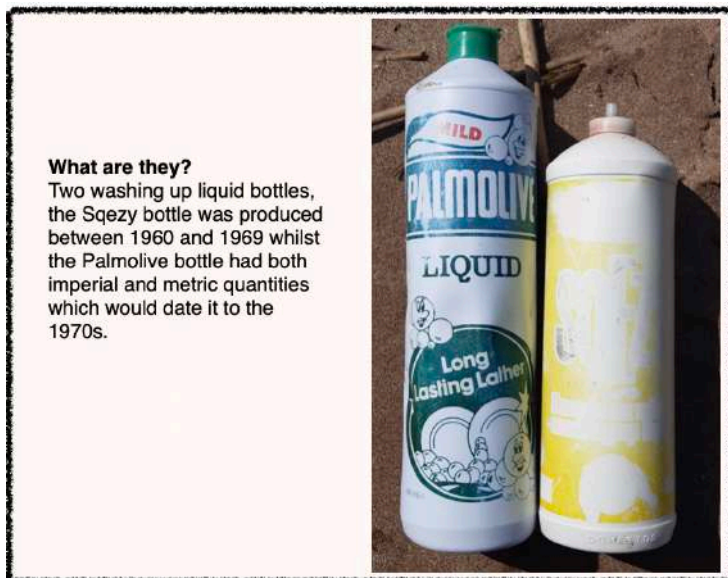
Volunteers from Monifieth Eco Force and Rotary have been beach cleaning along this area of the coast for more than a decade. The photo on the right is typical of the scene which greets volunteers particularly after storms and high tides.

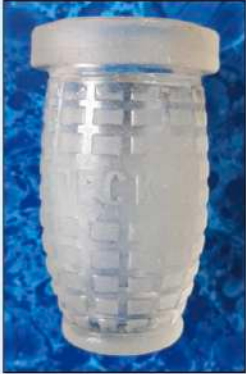
Seonaid June 2023

Found When and Where?
 Found on 17th June 2023.
 On the high tide mark between the Sentry point and the Buddon burn.
 Weather conditions Sunny. Sea Calm.

What is it?
 A glass jar which originated from Peck's. It is dated 1929 -1930 and is only slightly abraded.

The jar would have contained either meat or fish paste. Peck's was founded in 1891 and was based in South London. It has a flat section on the back where the label would have been.

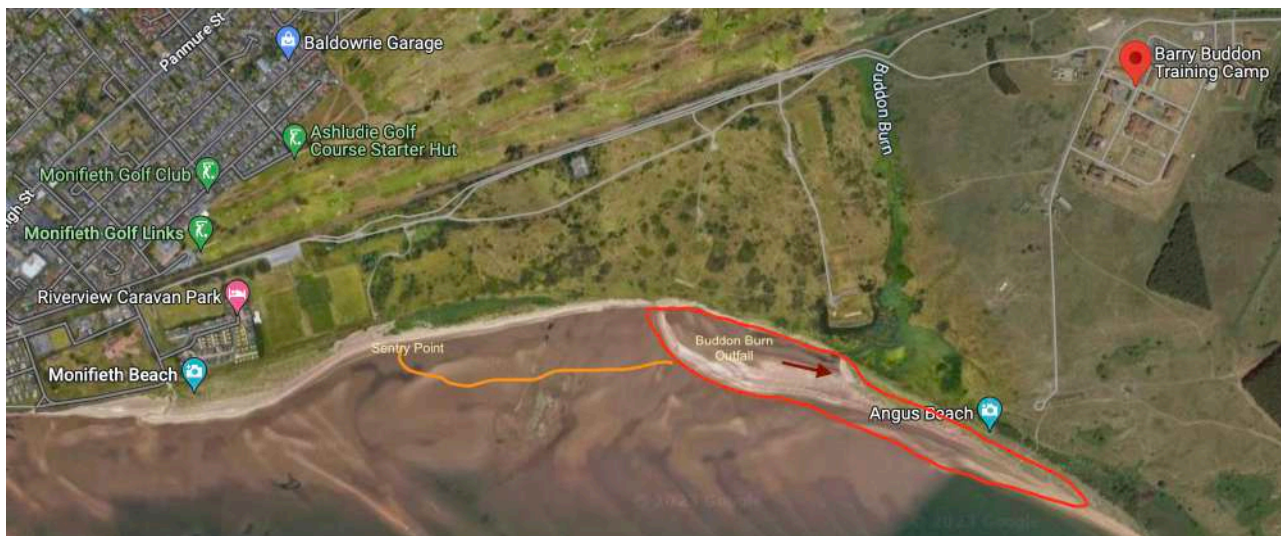
The waste is almost always found either on or above the level of the high tide mark. Most of it is collected between the level of the MOD Sentry point and Buddon burn highlighted on the map below. However, historic waste can also be found along the beach any where from the Monifieth Burn right up to Buddon lighthouse. Very little waste is ever seen on the foreshore itself which can give the initial impression that Buddon is a beautiful stretch of clean beach. It should be noted that the foreshore is not in the ownership of the Crown or the Local Authority. As far as we have been able to ascertain it is not in the ownership of the MOD.

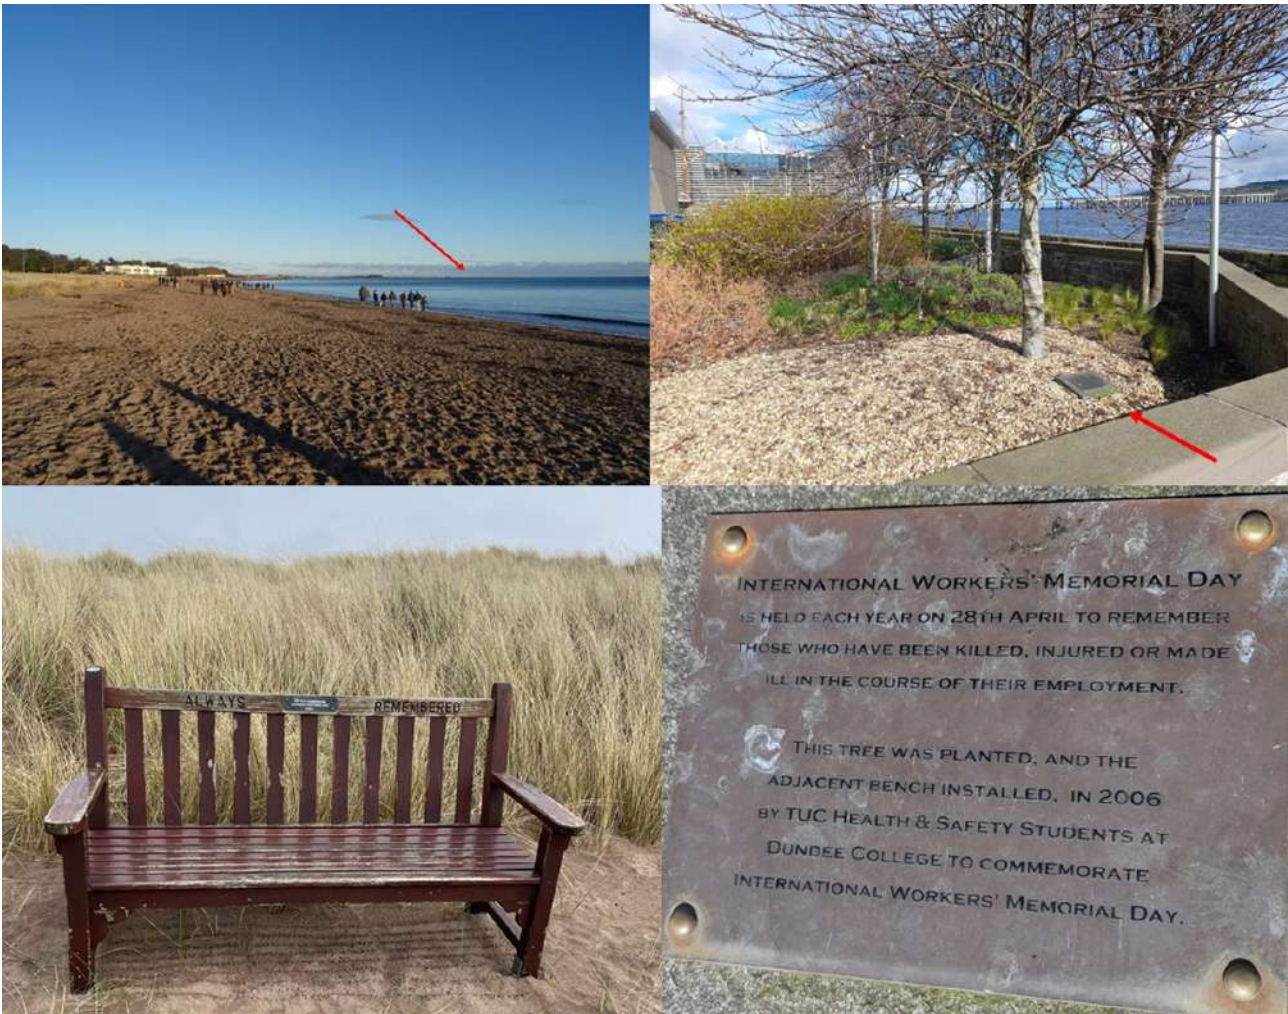
Point at which memorial bench entered the water in Dundee

The idea that the waste is flowing from the vicinity of Dundee is supported by the appearance of another unusual item washed up in the same location. A full sized memorial bench was thrown into the Tay at Riverside by vandals and washed up at Buddon in April. The bench was identified by its plaque which was to commemorate workers who have been killed or injured in the course of their employment. This was installed in gardens on the waterfront in Dundee in 2006 by students from Dundee College to commemorate International Workers Memorial Day. The photos below show the relationship between Riverside where the bench entered the Tay and the point at which it was washed up on Buddon beach. We are hoping that the bench can be returned to the gardens in the near future.

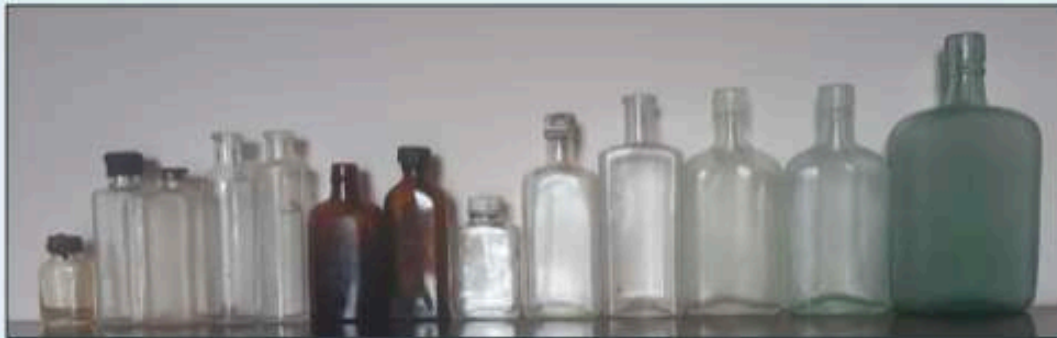
In considering which of the historic landfill sites the Buddon waste may be coming from, it may be worth considering which sites were more likely to have accepted clinical waste historically. Most of the old medicine bottles below date back to the early 1900s. In April 2023, a full prosthetic limb with a shoe attached was also found washed up.

What are they? Old medicine bottles dating back to the early 1900s

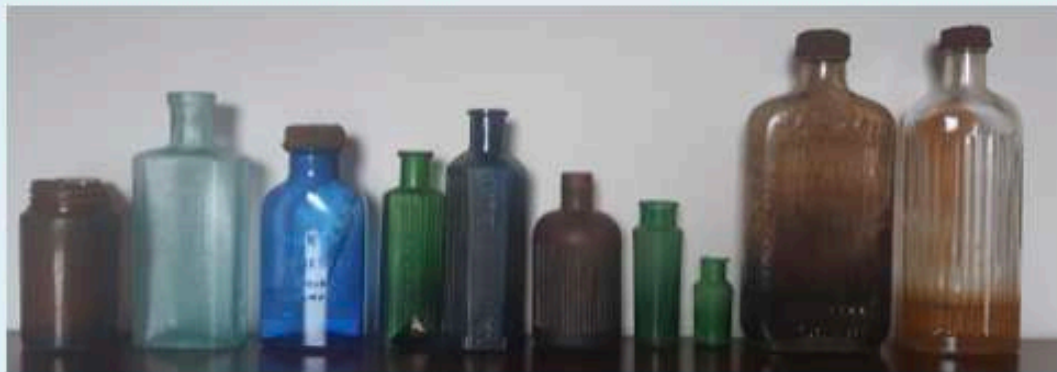
Photo below; 2 Victorian poison bottles, Milk of Magnesia, Kruschen Salts and Galloways Cough Syrup.

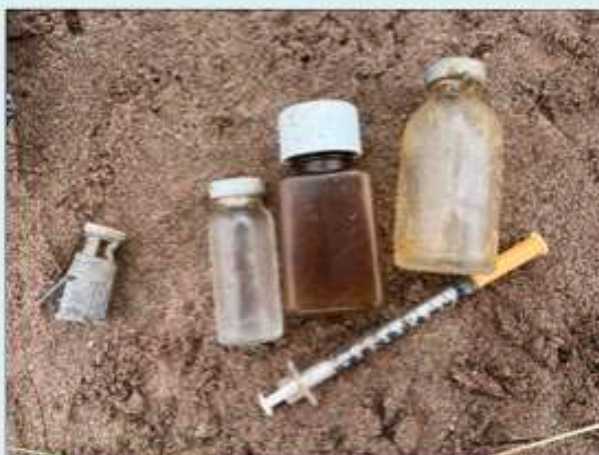
Left: Example of the type of medicine bottles found on **8th April 2023**.

Around 30 were collected in total and most of them were glass. Some had contained drugs which would have been administered by injection.

Clearly the plastic syringe and bottle are more modern but nevertheless adds weight to the idea that clinical waste forms part of the landfill escape.

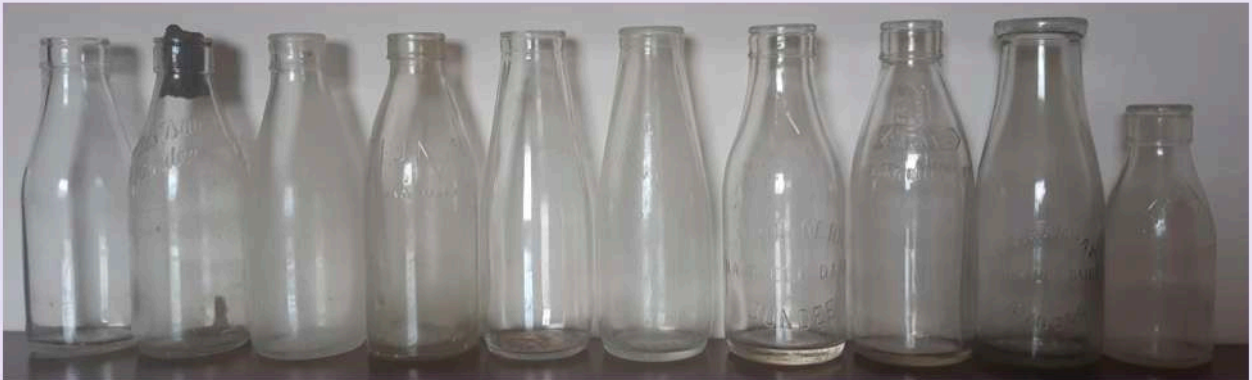
Old Glass Milk Bottles. Note that they are in good condition and most of them originate from the Dundee area. From Left to right;

1. Newton of Baldovan, Dundee
2. Guild's Dairy, Dundee
3. James Fitchet, No 3 Holding, Dryburgh, Dundee
4. DPM, Dundee 1933
5. Forthill Dairy, Broughty Ferry 1949
6. G Bathie, Shepherd's Loan, Dundee
7. John Kerr, Balfield Dairy, Dundee
8. SCWS (Scottish Cooperative Wholesale Society)
9. R T Ramsay, Dundee
10. City of Perth Co-op Society Ltd

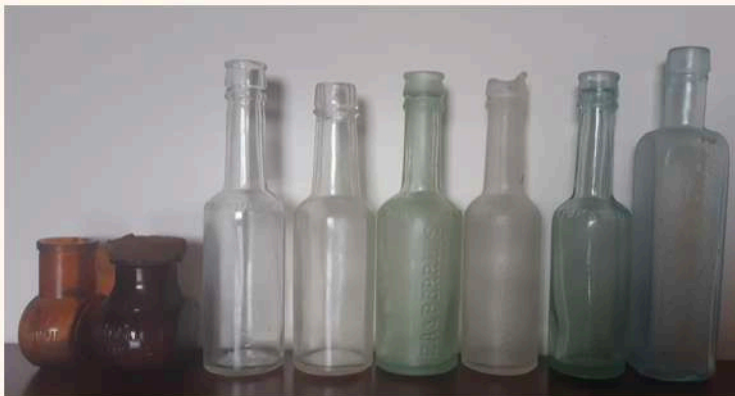
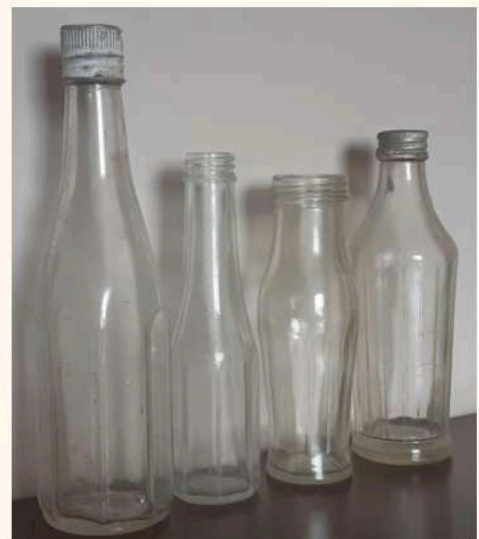
Photos: Seonaid

The 2 oz Bovril bottle pre dates 1913.

The condiment bottles include 2 Bovril bottles, Goodall Backhouse, Lee & Perrins, and Brand & Co Mayfair The A1 Sauce.

The Heinz bottles are more recent.

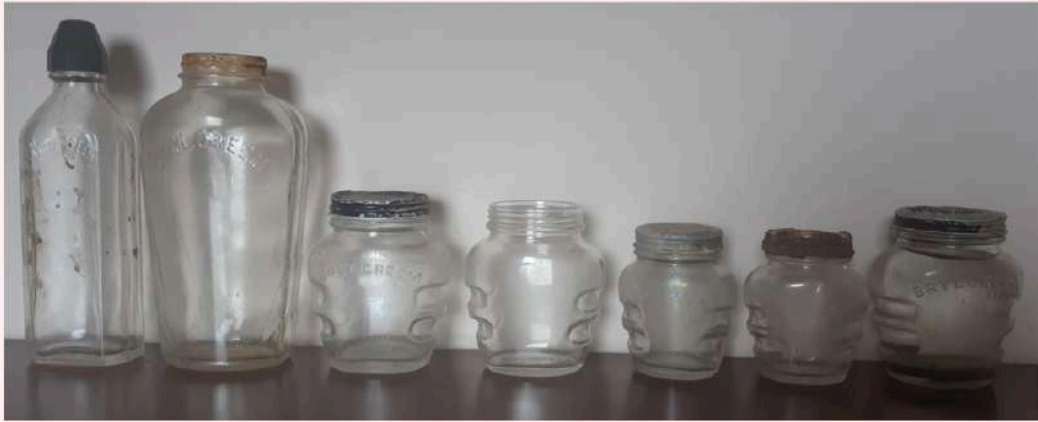
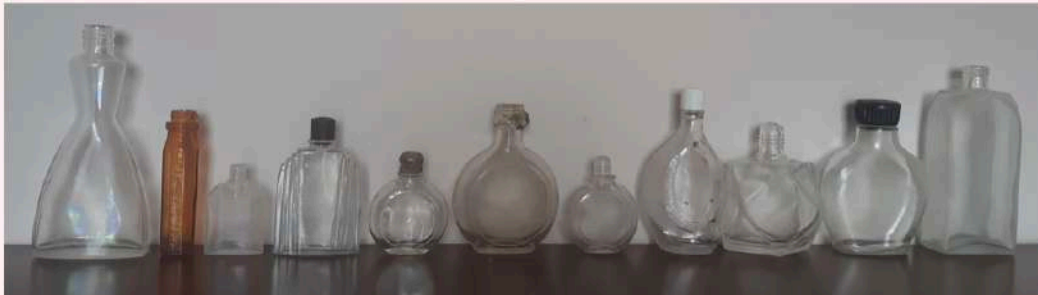
Glass Brylcreem and Cologne bottles. The Brylcreem bottles can be traced back to the 1930s.

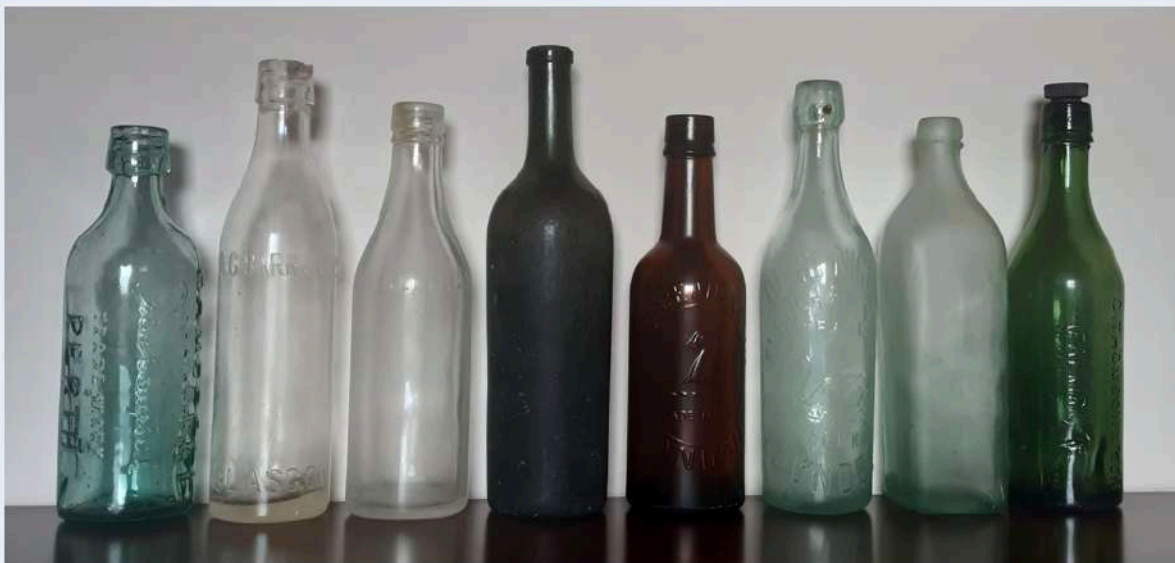
Photos: Seonaid

What are they? Drinks bottles dating back to the early 1900s.

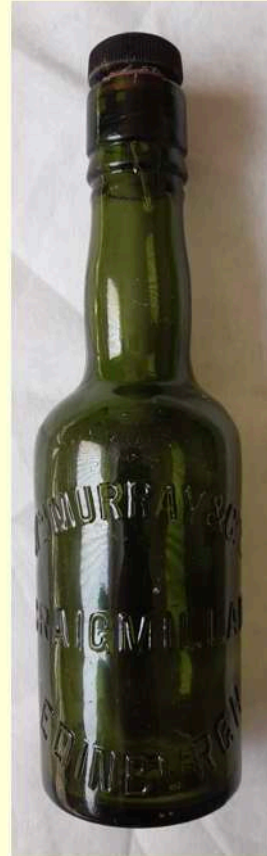
Photo:
Seonaid

This glass bottle is believed to be late 19th century as it has an applied neck and the glass is full of bubbles.

The Craigmillar Brewery was founded in 1880 at Ednam before relocating to Duddingston in 1886. It eventually closed in 1963.

The bottle is in remarkably good condition and the fact that it has survived intact despite having such a long neck is worthy of note.

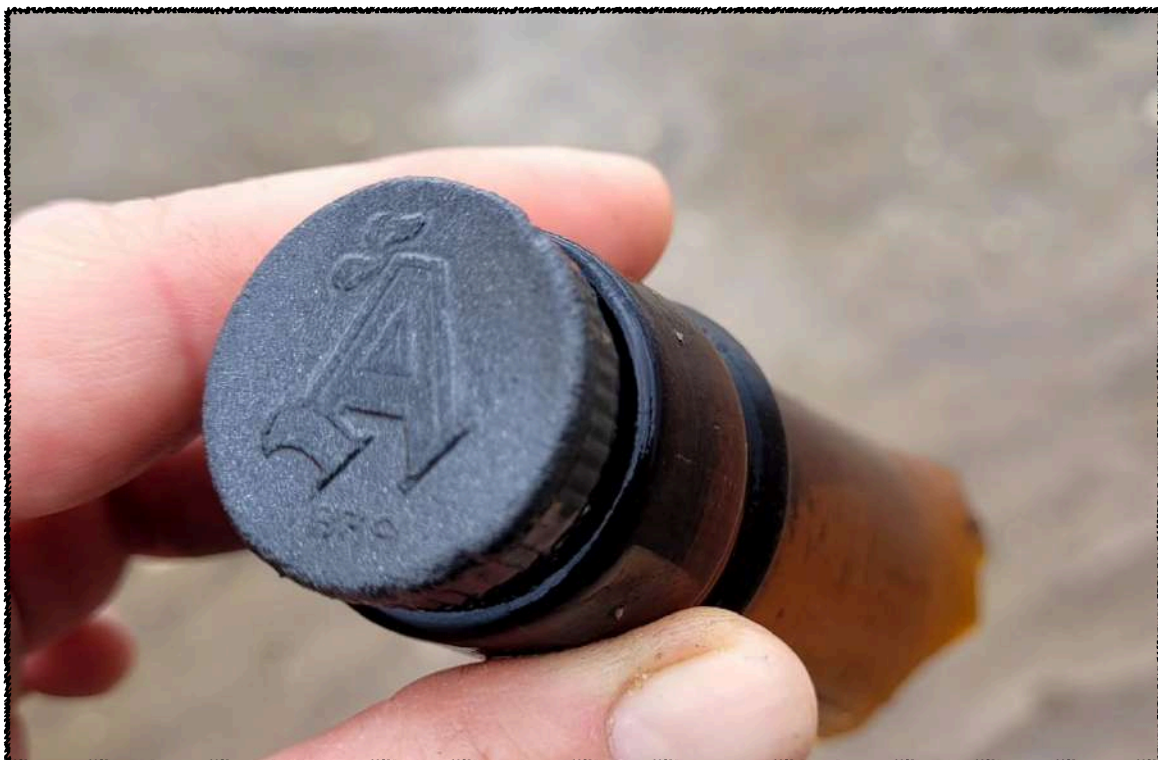
Photo:
Mysha
June 23

Hundreds of Vulcanised rubber stoppers, glass and ceramic stoppers have also been found. They originate from many different breweries, aerated water bottlers and soft drinks manufacturers. Seonaid records that vulcanised rubber was patented by Charles Goodyear in 1846 and the vulcanised rubber screw stoppers were invented by Henry Barratt in 1872.

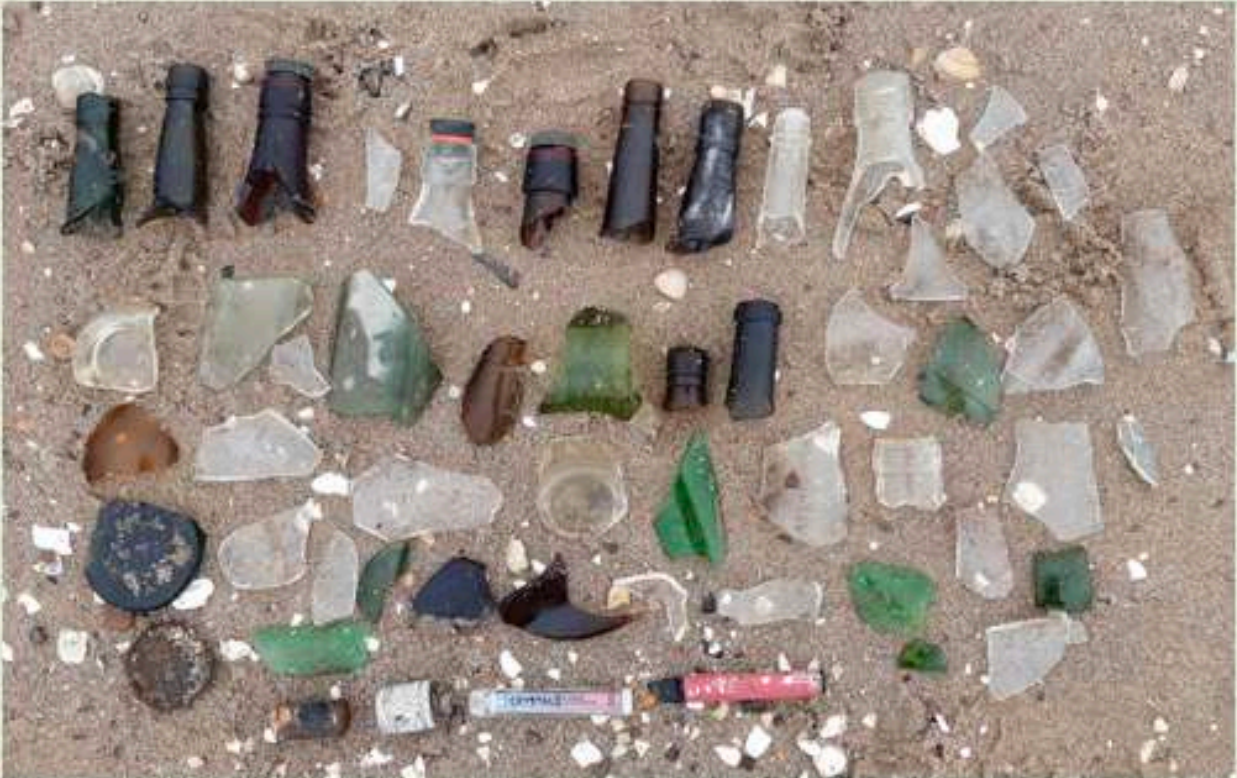
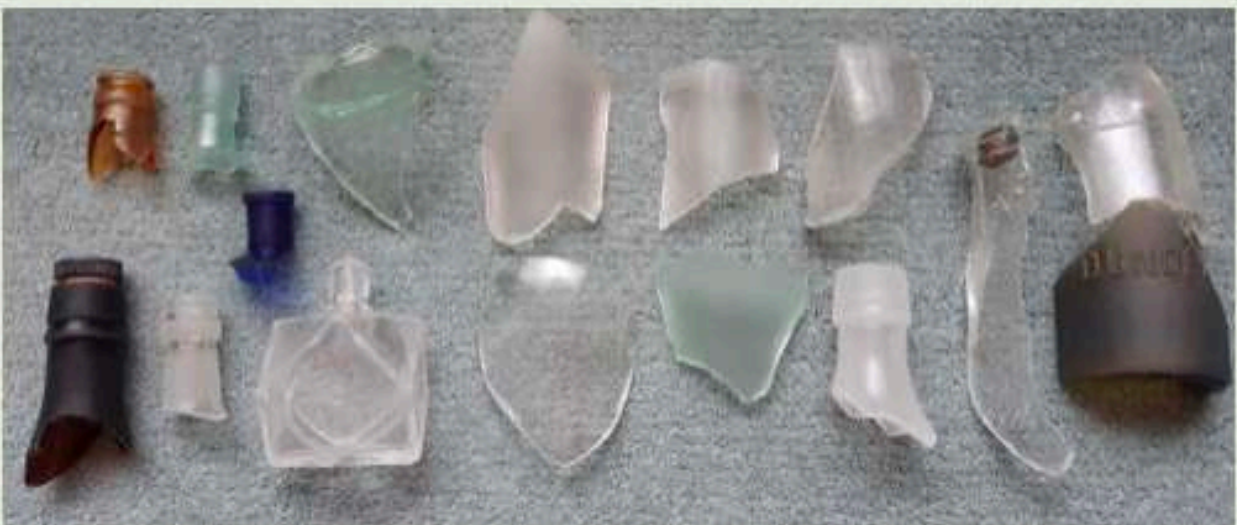
Photo: Seonaid

All found in May 2023. The 3 vulcanised rubber stoppers all originated in Dundee. Two from Stillade and one from Ballingall Brewers of Lochee (1844-1964). Vulcanised rubber stoppers were invented in 1872 and used up to around the 1960s when they were superseded by metal screw tops.

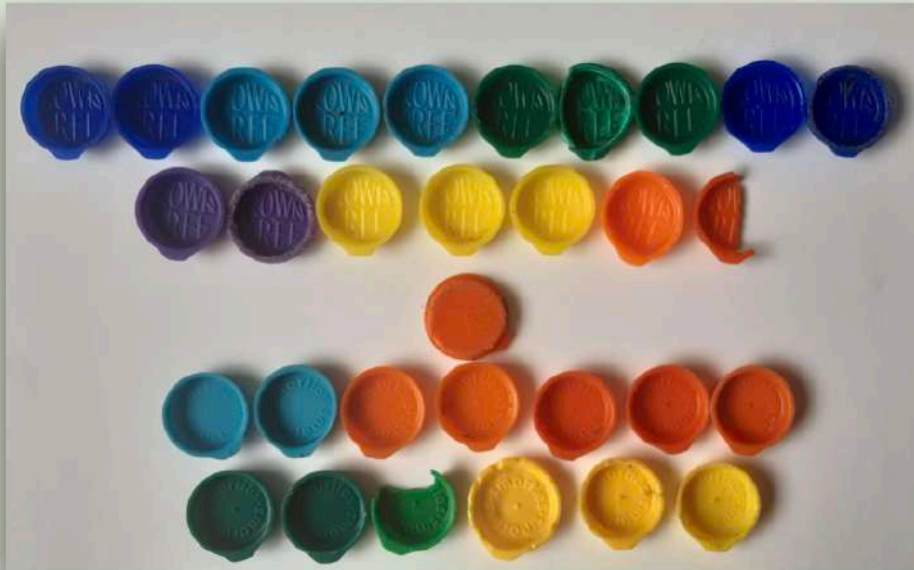
Photo:
Seonaid

Even smartie lids hold a significance with the lids below being dated between 15 and 50 years old

Smartie lids.

- Rowntree lids with lower case letters on reverse date from 1971 to 1988.
- The orange lid in the middle with the spaceship on it is from a SMARTIANS limited edition pack issued around 2002. The smarties inside were green with an alien face on them.
- The lids with embossed with 'smarties' date from 1988 when Nestle took over Rowntree but were phased out in 2005 when the tubes had pop up cardboard tops incorporated to reduce use of plastic.
